FLOOD INVESTIGATION REPORT

23 June 2016

HILLINGDON
LONDON

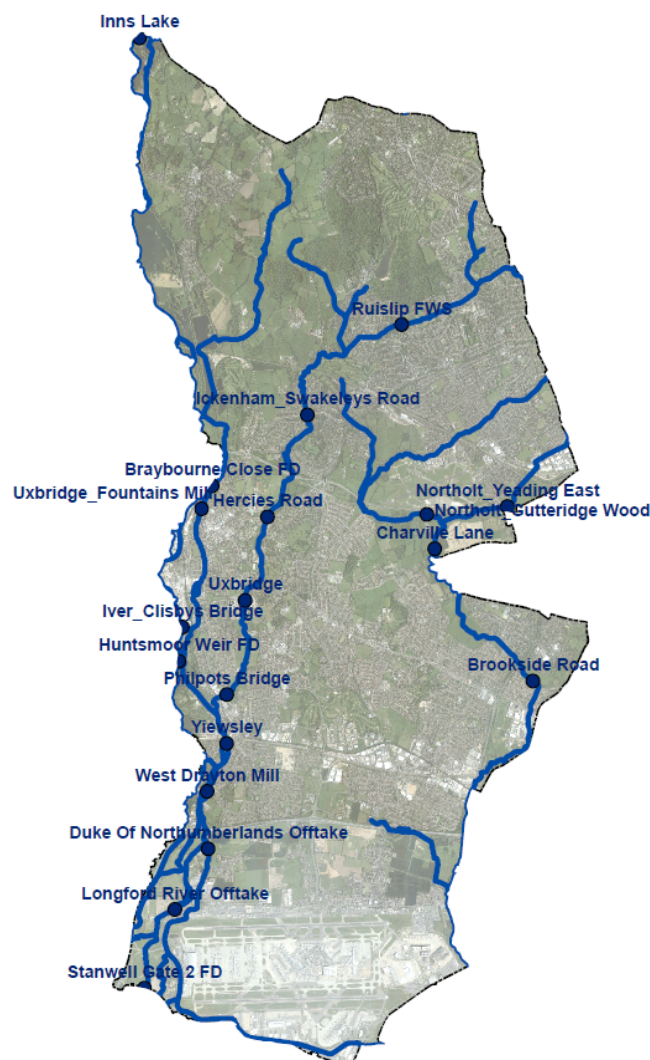
Map 2 Environment Agency Flood Warning gauge locations

After the event the detailed river level data was requested by the Council from the Environment Agency. The levels are taken at gauges on the rivers at certain points in the catchment on a 15min interval during a flood event. Map 2 shows the location of these gauges.

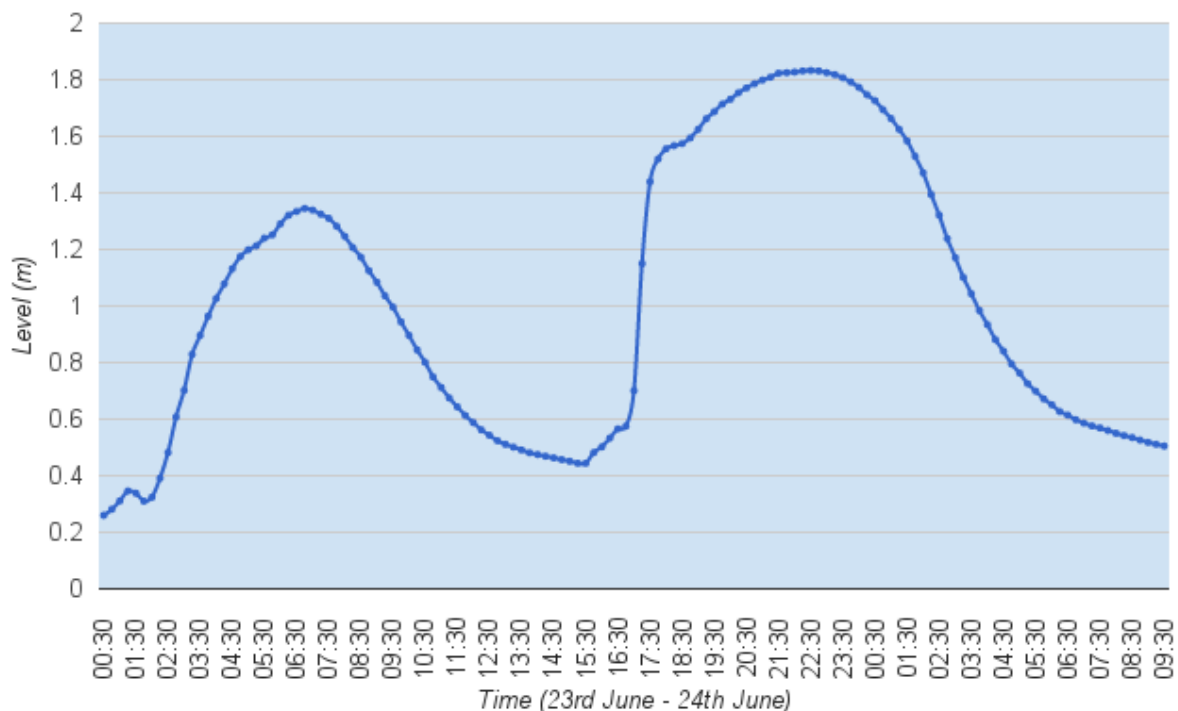
Graph 1 Environment Agency River Pinn levels at Ruislip FWS 23rd June - 24th June

The River Pinn responds quickly from the initial time of rainfall at 12:00 am on the morning of the 23rd June, however on a saturated catchment with much more intense rainfall even though volumes were considerably less the River Pinn responded almost instantaneously.

The River Pinn is known to respond quickly and can be observed to rise and fall back within banks in approximately 12 hours. Flooding is considered possible above 1m, a level which was reached twice on the 23rd June.

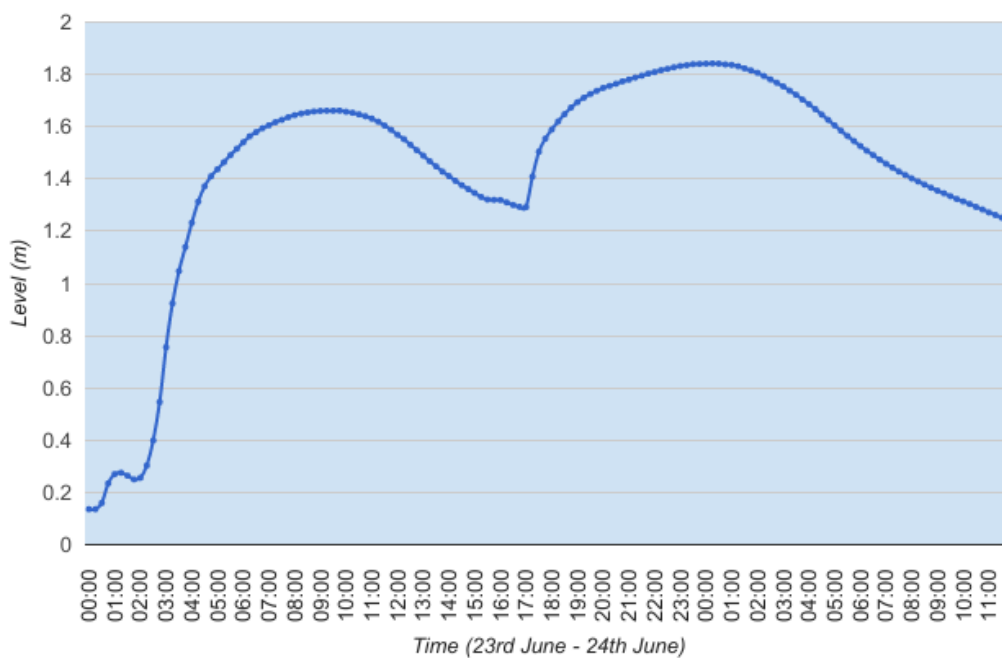
Graph 2 Environment Agency Yeading Brook River Levels at Northolt Gutteridge Wood Gauge 23rd - 24th June 2016

The information from the Northolt Gutteridge Wood gauge as the location closest to major flooding on the A40 has been shown on a graph to highlight the response of the Yeading Brook to the rainfall.

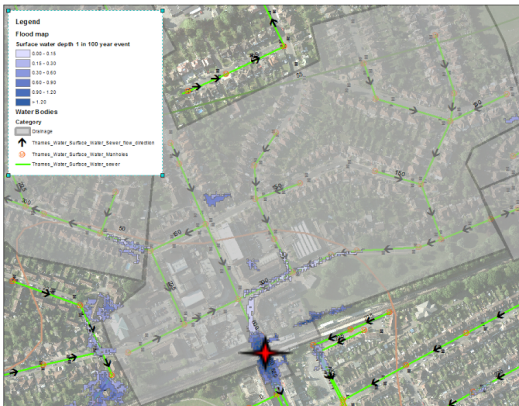
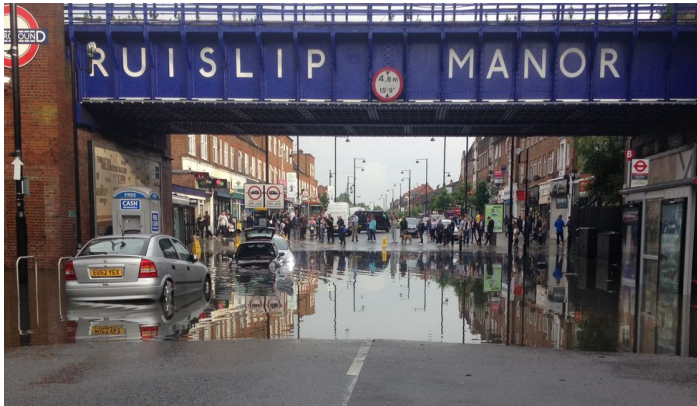
Area affected	1) Victoria Road, Commercial Premises and Ruislip Manor Station, Ruislip HA4 9A		
Date of flooding	23/06/2016		
Grid Reference	X 510077 Y 187234		
Land ownership	LU, LBH Adopted Road and Commercial Landowners		
Map of Area			
Location of flooding marked as a red star. Grey outline - Thames Water catchment.		Photographs taken from resident Simon Rowley published on Get West London http://www.getwestlondon.co.uk/news/west-london-news/motorists-kinds-mishaps-after-storms-11521084

Flooding duration	Evening 6.00 - 9.00pm		
Source of flooding	Surface water		
Cause/ Pathway	Heavy rainfall could not drain away quickly enough, causing water to pond under the bridge.		
Impact of flooding	Flooded internally - Commercial		13
	Flooded under floorboards		0
	Affected (ie gardens and front drive/garages)		0
Evidence	Reports from residents		Yes
	Identified on the flood map for surface water		Yes

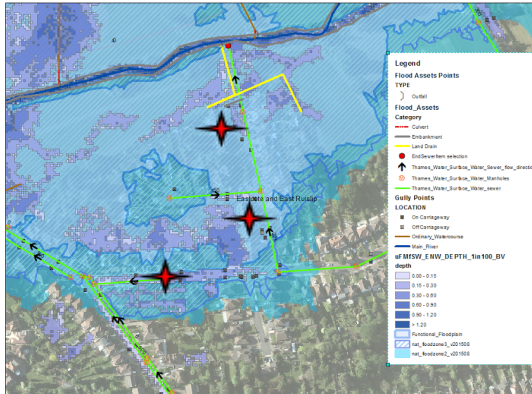
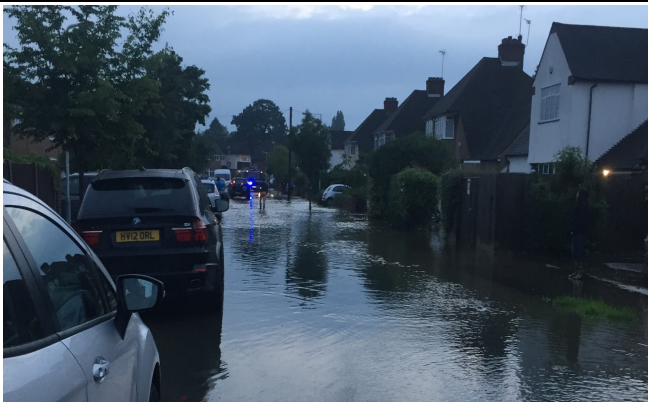
Area affected		2) Brook Drive, Brook Close and Evelyn Avenue, Ruislip HA4 8A	
Date of flooding		23/06/2016	
Grid Reference		X 509443 Y 187988	
Land ownership		LBH and Residents	
Map of Area			
Location of flooding marked as a red star		Photo from resident

Flooding duration		Evening 6.30 - 12 midnight	
Source of flooding		Surface water then main river	
Cause/ Pathway		The River Pinn burst its banks thereby restricting the ability of the surface water sewers to discharge and overwhelming them	
Impact of flooding			Brook Drive Evelyn Avenue
		Flooded internally	10 3
		Flooded under floorboards	1 0
		Affected (ie gardens and front drive/garages)	4 0
Evidence		Reports from residents	Yes Yes
		Identified on the flood map for surface water	Yes Yes
		Identified at risk of flooding from river (Flood Zone)	2/3/3b 2/3
		Critical Drainage Area (identified in the Surface Water Management Plan for Hillingdon)	No No

History of flooding		Brook drive has previously flooded a number of times from the River Pinn, including 1977, 2013, 2014 and 2015. Evelyn Avenue in 1977.	
Summary		An unusually extreme amount of rain fell over only an hour, causing the water levels in the River Pinn to rise, this caused surface water sewers not to be able to discharge and water backed up and couldn't flow away from the roads. Water also built up in the fields behind the properties	
London Borough of Hillingdon		Actions completed Highways Maintenance Service - In addition to the annual maintenance the Highways service have checked and cleared the gullies, to ensure that the rain had not washed further debris into the gullies blocking them. Gullies will be maintained more frequently as an area of higher priority. Green Spaces - The Council have checked the drainage within the Kings College Playing fields managed by the Green Spaces team. Flood and Water Management Officer - The Council organised a meeting on the 27th October 2016 for residents to report issues and explain the roles and responsibilities.

Action by Thames Water		<p>The residents have advised the Council they have called to report flooding to Thames Water. However Thames Water provided their sewer flooding database of flooding reports in November to the Council, this location is not on the list provided by Thames Water, so that it would appear Sewer Flooding Questionnaires have not been filled in.</p> <p>Thames Water have undertaken cleaning of a section of the surface water sewer in Evelyn Avenue, and surveyed a section of the surface water network in Brook Drive.</p> <p>On Brook Drive on 26/06/2016 the camera survey found a belly in the foul sewer line and several lips. On 15/08/2016 it was identified that subsidence had caused the belly and that the pipe needs to be replaced. On 08/06/2017 the replacement of 10 m of pipe was completed. This does not relate to the flooding.</p> <p>On Evelyn Avenue on 02/2017 a clean and survey of 68m of the surface water line was carried out and silt/debris was cleared and it was identified that concrete may be in the line. On 03/2017 the line was camera surveyed and pressure jetted. Roots and concrete were identified in the line. 04/2017 a potential belly was identified and the manholes in the gardens were found to have been altered to be too small to allow full investigation. 05/2017-06/2017 works are ongoing to rebuild the manholes to allow further investigation.</p>

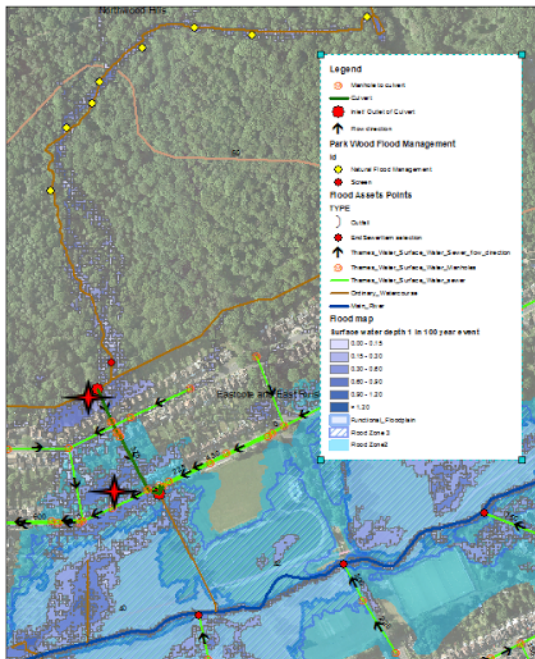
Area affected	3) Broadwood Avenue and Park Avenue, Ruislip HA4 7		
Date of flooding	23/06/2016		
Grid Reference	X 509278 Y 188318		
Land ownership	LBH and Residents		
Map of Area		Photo	
Location of flooding marked as a red star		None

Flooding duration	Approximately evening 5.30pm - 4.00am		
Source of flooding	Ordinary watercourse, from Park Woods and surface water		
Cause/ Pathway	Multiple overland flow routes. Water from the woods, from two different directions meet at the rear of no 58/60 Broadwood Avenue and flows into a culvert. When the culvert was full, water backed up and flowed out of the ditch and into rear gardens on Broadwood and down the side of houses. Water also built up on the roads and flowed into the rear of houses on Park Avenue. Water on Park Avenue observed coming up from manhole outside no 95. Water was observed exiting the gullies from the surface water sewer.		
Impact of flooding		Broadwood	Park

To be completed	<p>Green Spaces - Further discussion with Affinity will be undertaken on Affinities plans both in the short term and long term.</p> <p>Highways Service - Residents have requested a review of the speed table to allow water to flow along the road, and away into other gullies and sewers.</p> <p>Flood and Water Management Officer - The Council is planning to expand the natural flood management, already implemented. This takes on board advice from the Environment Agency and working with other organisations. Further information can be found on a leaflet produced for the Residents Flood Forum on the 17th May 2017</p> <p>The Council is also providing feedback to national body developing a protocol on the transfer of assets to ensure that an appropriate process is developed for the future, in similar situations to ensure there better understanding of what asset management means to potential riparian owners.</p>

Thames Water	Action taken	<p>Residents reported the issue and Thames Water checked the manhole outside no 95. They have provided a replacement heavy duty manhole cover that should reduce the likelihood of excess flow in the pipe lifting it.</p> <p>Thames Water have not advised the Council of any meetings they have had with residents and have not advised of the outcome of such a meeting, despite a number of requests subsequently. It is not on the sewer flooding database provided by Thames Water so it would appear that Sewer Flooding Questionnaires have not been filled in.</p> <p>Thames Water cleared the surface water sewers on Park Avenue on 19th October. Thames Water have also undertaken a condition survey of the culvert which shown the pipe to be in a good condition.</p> <p>Since this time residents advised the Council that Thames Water had written to them to advise the culvert was no longer Thames Water responsibility. Thames Water have written to the Council stating that they believe responsibility for the culvert will pass to riparian owners.</p>

Action to be taken	A senior case officer leading on this has provided feedback to the Council on the next steps they intend to take, which includes advising those residents affected on the Thames Water position and providing the CCTV of the culvert condition.
Action by Affinity Water	Action taken	Affinity Water advised in February 2017 that they were undertaking a condition survey of the supply pipe, after the Council conveyed the residents concern about burst pipe. The pipe then burst again in March affecting a different area along Bury Street. Further information is provided in leaflet drafted for the Residents Flood Forum on the 17th May 2017.
	Action to be taken	<p>In addition Affinity are improving their leak detection system to improve the speed at which they can respond to a burst and notifying the Council should this occur on Council land.</p> <p>They are working closely with the Council to arrange the condition survey and any works they plan within the Park Woods as well as options to contribute to any flood mitigation.</p>

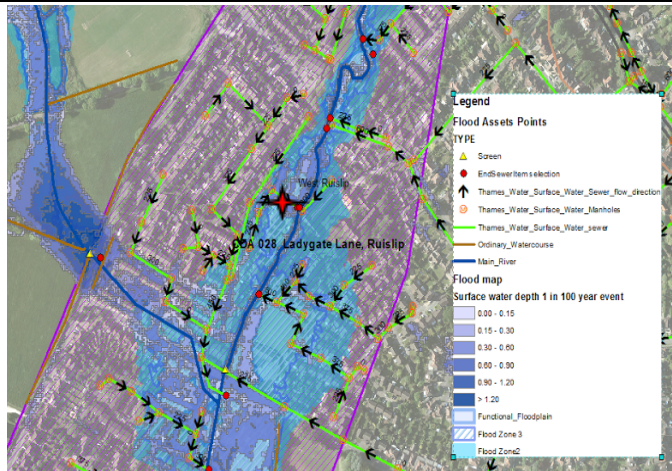
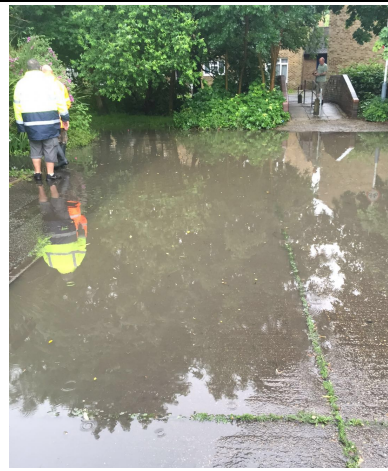
Area affected		4) Wallington Close, Ruislip HA4 7Y	
Date of flooding		23/06/2016	
Grid Reference		X 508177 Y 188375	
Land ownership		Land Owner - residents and LBH (St Catherines Court)	
Map of Area		Photo	
Location of flooding marked as a red star Critical Drainage Area in purple		Photo provided by resident facing the Cannon Brook

Flooding duration		From late afternoon to 1.00am on the 24th June	
Source of flooding		Main river - Cannon Brook	
Cause/ Pathway		Flooding from the Cannon Brook	
Impact of flooding		Flooded internally	5
		Flooded under floorboards	0
		Affected (ie gardens and front drive/garages)	3
Evidence		Reports from residents	Yes
		Identified on the flood map for surface water	Yes
		Identified at risk of flooding from rivers and the sea (Flood Zone)	3b
		Critical Drainage Area (identified in the Surface Water Management Plan for Hillingdon)	Yes
History of flooding		A similar event occurred 15 years ago, and in 1988 and 1977.

<p>limit the discharge. These were not open during the flood event in anticipation of the rain.</p> <p>A Flood Risk Assessment was undertaken for works at the Ruislip Lido and it recommended a number of actions to reduce flood risk along the Cannon Brook. The Council have acted on these recommendations and replaced the debris screen at Ladygate Lane and cleared debris and silt from the river near Howletts lane as part of these works in 2014.</p> <p>Highways Service - The Council clear the Lady Gate screen twice a week, and additionally when bad weather is forecast.</p>
	To be completed	<p>Highways Service - Will consider the resurfacing of the adopted public footpath once any work of bank protection has been undertaken.</p>
Action to be taken by the Residents		<p>The residents have collected evidence of the issues at Wallington Close and have identified a low spot on the bend of the river where they believe flow first came out of the Cannon Brook Main river.</p> <p>The residents are responsible as Riparian Owners for maintenance of their part of the Cannon Brook.</p> <p>It is recommended they all write their own personal floodplans, and purchase flood protection measures such as Flood doors, and where possible create a Flood Action Group.</p> <p>If residents are concerned about blockages on the debris screen, contact the Highways Service via the Contact Centre to ask them to clear it.</p>

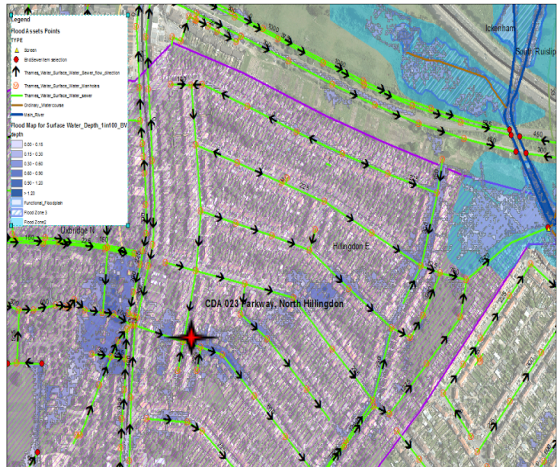
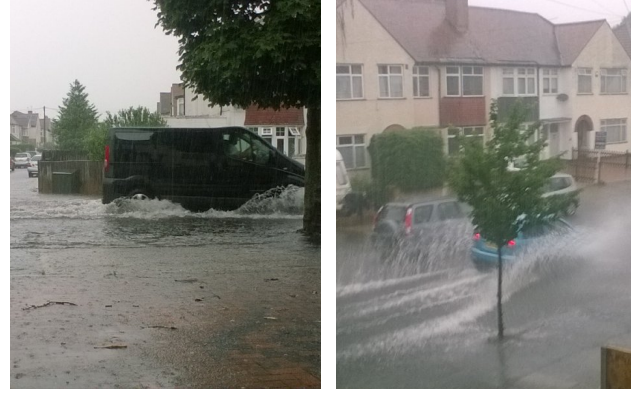
Area affected	5) Regent Avenue, (Including Long Lane, Windsor Avenue) UB10 9A	
Date of flooding	23/06/2016	
Grid Reference	X 507769 Y 184221	
Land ownership	Land owner	
Map of Area	Photo	
Location of flooding marked as a red star Critical Drainage Area in purple	Photographs taken from social media/resident showing Windsor Avenue.

Flooding duration	Approximately 6:30pm - 7:30pm	
Source of flooding	Surface water	
Cause/ Pathway	Water flowed down Victoria Avenue into Regent Avenue and couldn't drain away. Water built up in the park in Brighton Close to the rear of properties along Regent Avenue spreading out into gardens. Windsor Avenue also experienced water building up on the road.	
Impact of flooding	Flooded internally	4
	Flooded under floorboards	0
	Affected (ie gardens and front drive/garages)	36
Evidence	Reports from residents	Yes
	Identified on the flood map for surface water	Yes
	Identified at risk of flooding from rivers and the sea (Flood Zone)	No

Residents	Actions Completed	Residents have reported this to the Fire Brigade Ref 0792472306 2016 and Hillingdon Parks 5200936, and produced a petition.
	To be completed	The Council recommend residents draw up a Personal Flood Plan, and purchase products to protect homes from flooding such as air brick covers. As Regent Avenue does not appear on Thames Water's sewer flooding records, the Council recommends residents should report this to Thames Water and fill in the Questionnaire .
Action by Thames Water		Thames Water has received a single property request to clean up after a flooding event.

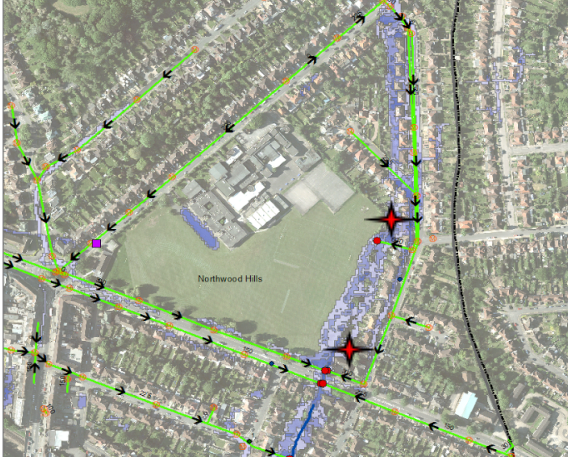
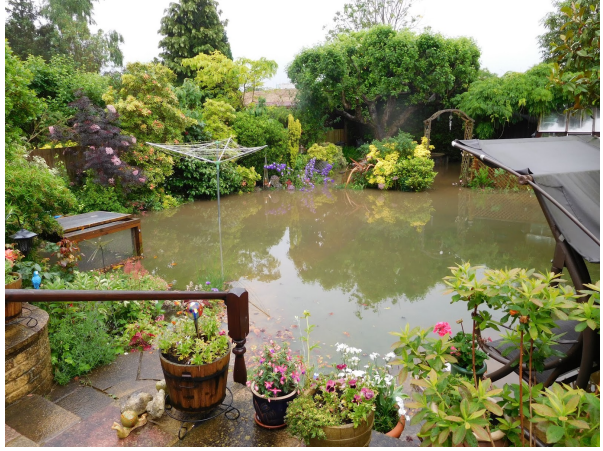
Area affected	6) Alandale Drive, Northwood HA5 3U	
Date of flooding	23/06/2016	
Grid Reference	X 510691 Y 190547	
Land ownership	Northwood School, private residents and LBH adopted highway	
Map of Area	Photo	
Location of flooding marked as a red star	Photo from residents of the rear gardens

Flooding duration	Approximately 1 hour	
Source of flooding	Surface water and ordinary watercourse - Joel Street Ditch	
Cause/ Pathway	Surface water flowed down Alandale Drive from the direction of Potter Street. This water couldn't drain away into sewers flooding those on Alandale from the front. As water drained away into the sewers, these drained to the rear of properties into Joel Street Farm Ditch which then overflowed into gardens down Alandale Drive.	
Impact of flooding	Flooded internally	4
	Flooded under floorboards	0
	Affected (ie gardens and front drive/garages)	3
Evidence	Reports from residents	Yes

Identified on the flood map for surface water	Yes
	Identified at risk of flooding from rivers and the sea (Flood Zone)	No
	Critical Drainage Area (identified in the Surface Water Management Plan for Hillingdon)	No
History of flooding	The Joel Street Farm Ditch, which runs alongside Joel Street and next to Briarwood Drive, has frequently been the cause of flooding of gardens over the past few years.	
Summary	After a short intense period of rainfall, the road became flooded as the surface water sewers didn't have the capacity to take the water. Water built up on the road and properties were flooded internally as a result. These sewers drain into the Joel Street Ditch to the rear of Alandale and the ditch then overflowed into gardens.

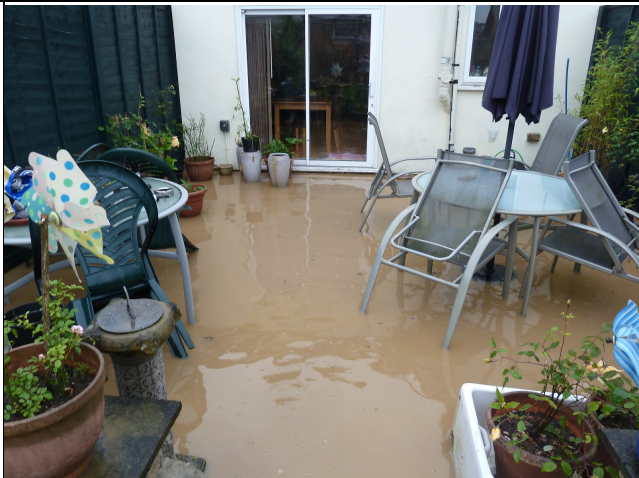
Area affected		7) Sutton Court Road, Uxbridge UB10 9H	
Date of flooding		23/06/2016	
Grid Reference		X 507847 Y 183546	
Land ownership		Abbotsfield and Swakeleys School, LBH open space and private road and residents	
Map of Area		Photo	
Location of flooding marked as a red star		Photograph provided by resident

Flooding duration		Evening of the 23rd June. Not known exactly	
Source of flooding		Surface water	
Cause/ Pathway		Heavy rain not absorbed within the school playing fields flowed towards the low lying green space and ponded there. This built up until it spilled across to the adjacent private road and spilled across into residents rear gardens homes.	
Impact of flooding		Flooded internally	3
		Flooded under floorboards	0
		Affected (ie gardens and front drive/garages)	4
Evidence		Reports from residents	Yes
		Identified on the flood map for surface water	Yes
		Identified at risk of flooding from rivers and the sea (Flood Zone)	No

Critical Drainage Area (identified in the Surface Water Management Plan for Hillingdon)	Yes
History of flooding		Gardens flooded previously 14/11/2014 and 09/01/2015, 18/04/2016	
Summary		After a short intense period of rainfall, lasting for approximately an hour, water flowed down the school fields into residents homes.	
London Borough of Hillingdon	Actions completed	<p>The Local Planning Authority - The Council have reviewed the proposals for the redevelopment of the school to ensure that the redevelopment will reduce the surface water run off from the school site, through sustainable measures. Details contained within the planning application.</p> <p>The Council asked the developers to provide a bund to protect residents during the construction phase and continue to monitor works as they progress.</p>	
Residents	To be completed	The road to the rear of properties is privately owned and therefore landowner is responsible for maintaining any drainage and installing any needed.

Action by School		School to maintain the drainage regularly within the site.

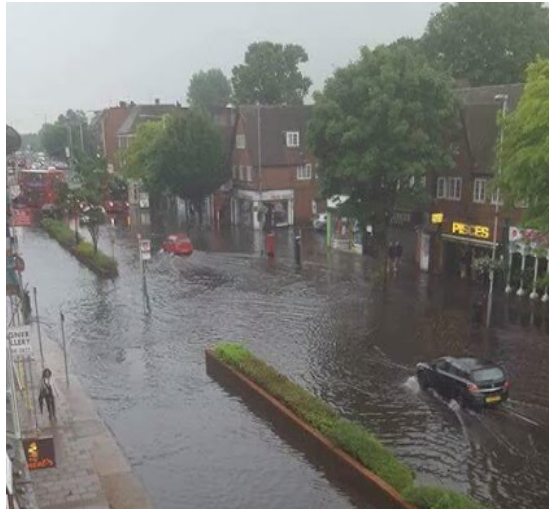
Area affected		8) Field End Road - Eastcote High Street, (also includes Hawthorne Avenue) Eastcote HA5 1R	
Date of flooding		23/06/2016	
Grid Reference		X 511065 Y 187746	
Land ownership		Commercial premises and Adopted Highway	
Map of Area		Photo	
Location of flooding marked as a red star		Photograph taken from social media

Flooding duration		Evening of the 23rd June not known exactly.	
Source of flooding		Surface water	
Cause/ Pathway		Overwhelming of surface water sewer by heavy rain.	
Impact of flooding	Flooded internally		3
	Flooded under floorboards		2
	Affected (ie gardens and front drive/garages)		0
Evidence	Reports from residents and social media		Yes
	Identified on the flood map for surface water		Yes
	Identified at risk of flooding from rivers and the sea (Flood Zone)		No
	Critical Drainage Area (identified in the Surface Water Management Plan for Hillingdon)		No
History of flooding		Previously on the 26th August 2015, and then 8th June 2016 http://www.getwestlondon.co.uk/news/west-london-news/north-harrow-station-closed-due-11446744 and subsequently on the 15th September - http://www.standard.co.uk/news/london/london-weather-flooding-after-met-office-thunderstorm-alert-a3346156.html

Summary		After a short intense period of rainfall, the surface water sewers were overwhelmed causing roads to flood. https://www.youtube.com/watch?v=zv9WouMN-t8	
London Borough of Hillingdon	Actions completed	The Highways service in addition to the annual clearing, have checked and cleared gullies in September. Gullies on Field End Road and Eastcote High Street will be maintained more frequently as an area of higher priority. The 'non property flooding' events of the 23rd June were reported to Thames Water by the Council who investigated it.	
	To be	The Highways projects team were considering potential works in the area, it was recommended that this project extended to include options to alleviate

completed	flooding. Feasibility, options and costings are being explored by the Highways Transportation and Projects team.
Residents	To be completed	The Council recommends considering installing flood protection measures such as flood proof doors. Further information can be found on the Hillingdon website.
Action by Thames Water		<p>Thames Water is responsible for the surface water sewers that the gullies drain into. There are two which run in different directions.</p> <p>Flooding was reported to Thames Water for 23rd June by the Council in September. The surface water sewer line was checked and found to be free flowing.</p> <p>Flooding was reported to Thames Water on the 9th June and the sewer questionnaire was filled in. A blockage on the sewer was found and cleared.</p> <p>Furthermore, it was identified as part of Thames Water's investigation that one of the sewers drain to a ditch within London Underground land, to the north of the station but south of the Council car park. This is a London Underground asset and Thames Water made London Underground aware.</p>

Action by London Underground		The Council have made a request to London Underground to provide information on the action they have taken following Thames Water's investigation findings. ie Assess the state of any drainage assets provide information on where water flows to. No response has been provided to date.

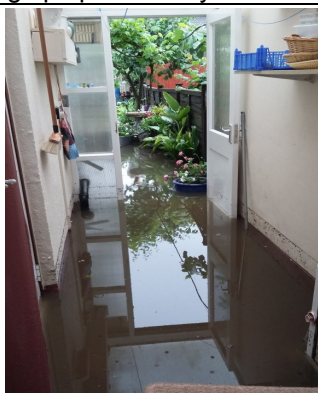
Area affected		9) Hilliard Road, Hallowell Road, Church Road and Northwood High Street, Northwood HA6 1	
Date of flooding		23/06/2016	
Grid Reference		X 509820 Y 190795 & X 509566 Y 190893 & X 509880 Y 191243	
Land ownership		Resident and LBH (St James Court)	
Map of Area		Photo	
Location of flooding marked as a red star		Photograph provided by resident

Flooding duration		Evening	
Source of flooding		Surface water	
Cause/ Pathway		Overwhelming of drainage system by heavy rain, water built up on the road and along private access track	
Impact of flooding		Flooded internally	3
		Flooded under floorboards	0
		Affected (ie gardens and front drive/garages)	3
Evidence		Reports from residents	Yes
		Identified on the flood map for surface water	Yes
		Identified at risk of flooding from rivers and the sea (Flood Zone)	No
		Critical Drainage Area (identified in the Surface Water Management Plan for Hillingdon)	No

History of flooding		2006 approximately and another event previous to that.	
Summary		After a short intense period of rainfall, lasting for approximately an hour, the surface water sewers were overwhelmed causing the roads to flood.	
London Borough of Hillingdon	Actions completed	<p>Highways maintenance - In addition to the normal maintenance programme the gullies were checked again after the event in July as requested by resident. Gullies will be maintained more frequently as an area of higher priority.</p> <p>The Council Housing service - responded to the immediate flooding.</p> <p>The Flood and Water Management Officer provided advice on roles and responsibilities to residents, and how to protect their homes.</p>	
Residents	To be completed	The Council recommend residents draw up a personal Flood Plan, and purchase products that can be purchased to protect homes from flooding through airbricks. Further information can be found on the Hillingdon website. Further recommendations on resident at Hilliard Road were made of a retaining wall at the edge of the rear garden to prevent water from the private access from entering the garden.

These locations are not on the sewer flooding register but residents have called Thames Water to make them aware of the issues. The Council is unaware what, if any, action has been taken at this location.

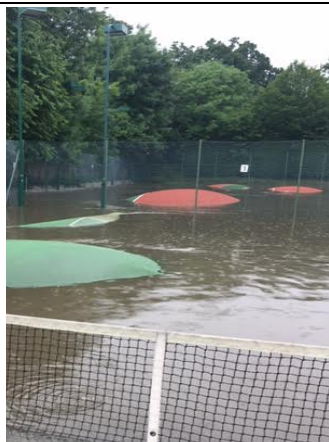
Area affected		10) Kaduna Close and Joel Street, Northwood HA5 2P	
Date of flooding		23/06/2016	
Grid Reference		X 510499 Y 188744	
Land ownership		Resident and Adopted Highway	
Map of Area		Photo	
Location of flooding marked as a red star		Photo from Tennis Club

Flooding duration		From 17:30 until the following morning	
Source of flooding		Main river - Joel Street Ditch	
Cause/ Pathway		Caused by rising water levels of the Joel Street Ditch, overflowed and ran down the road towards the River Pinn and into Kaduna Close and across the Tennis Courts and into the River Pinn	
Impact of flooding		Flooded internally	3
		Flooded under floorboards	0
		Affected (ie gardens and front drive/garages)	3
Evidence		Reports from residents	Yes
		Identified on the flood map for surface water	Yes
		Identified at risk of flooding from rivers and the sea (Flood Zone)	3/3b
		Critical Drainage Area (identified in the Surface Water Management Plan for Hillingdon)	No

History of flooding		Joel Street Ditch has previously spilled onto the road.	
Summary		After a short intense period of rainfall, the Joel Street ditch rose in level overflowing onto Joel Street. Water flowed down the road towards the junction of Joel street and High Road Eastcote. Water built up in Kaduna close and overflowed into the Tennis Club	
London Borough of Hillingdon	Actions completed	Highways Service -In addition to the normal programme of gully clearance the gullies were checked following the flooding to remove any silt and debris that may have been washed in. This was done on the 7th October.	
Residents	To be completed	The Council recommend residents draw up a personal Flood Plan. Further information can be found on the Hillingdon website. Also on products that can be purchased to protect homes from flooding through airbricks.	
Action by Thames Water		It can be assumed that this is a separate sewer however this cannot be confirmed without a survey having been taken.

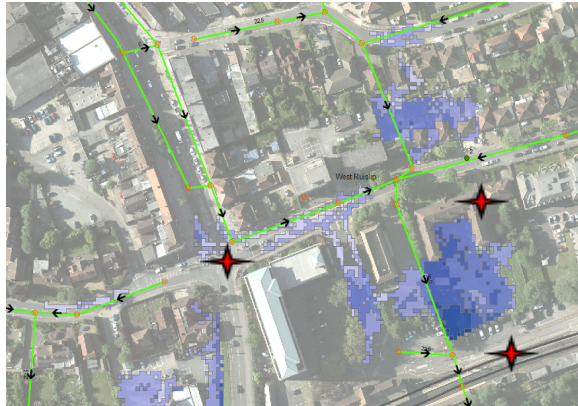
Flooding duration		Unknown	
Source of flooding		Surface water	
Cause/ Pathway		The surface water sewer could not cope with the amount of rainfall that fell. The road and subsequently the properties became flooded and a surface water manhole became dislodged.	
Impact of flooding		Flooded internally	4
		Flooded under floorboards	0
		Affected (ie gardens and front drive/garages)	1
Evidence		Reports from residents	Yes
		Identified on the flood map for surface water	Yes
		Identified at risk of flooding from rivers and the sea (Flood Zone)	No
		Critical Drainage Area (identified in the Surface Water Management Plan)	No
History of flooding		28th July 2014, 26th August 2015, 16th September 2016 and multiple other reports of the road having ponding water.

Summary		The short intense rainfall event caused the road to become flooded as the sewers could not cope with the amount of surface water. Water from the road then flooded the adjacent properties, including Fanuc House and spilling across into Central House .	
London Borough of Hillingdon	Actions completed	The gullies were checked in addition to the normal annual clearance on 23/06/2016 and were found to be clear and running. Gullies will be maintained more frequently by the Council Highways service as an area of higher priority.	
Residents	Actions completed	Residents reported to Thames Water that the sewers may be blocked or have defective pipework as there is always a puddle of water at a specific location and even more so after heavy rainfall. Some residents have installed flood protection measures such as air brick covers.	
Action by Thames Water		Extensive surveys and cleaning have been carried out along this road with silt/debris/rubble being removed from various locations. Silt and loose concrete

<p>have been removed from the surface water sewer. They have also cut root intrusion into the pipes.</p> <p>Residents have reported that Thames Water had been investigating the foul water sewers since 2014 with CCTV equipment. After this flood they found that it was the surface water sewer that was the issue on 23/06/2016.</p> <p>The Thames Water Sewer Flooding Questionnaire has been completed and submitted for flooding that occurred in September 2016.</p>
--	--

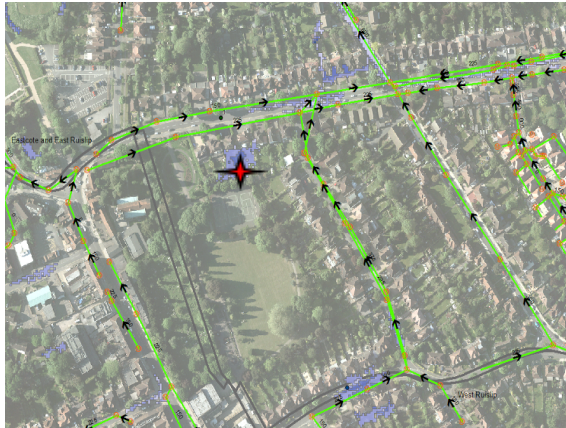
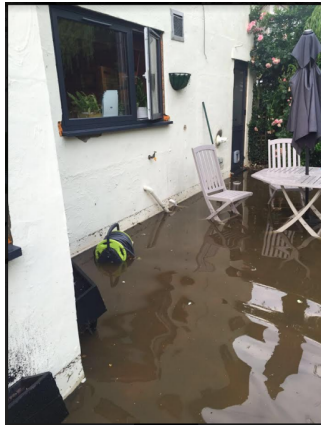
Flooding duration		Unknown	
Source of flooding		Surface water	
Cause/ Pathway		Surface water from the tennis courts flowed into the garden of one property. At another location surface water from the school playing field ran into the gardens of some properties.	
Impact of flooding		Flooded internally	2
		Flooded under floorboards	0
		Affected (ie gardens and front drive/garages)	3
Evidence		Reports from residents	Yes
		Identified on the flood map for surface water	Yes
		Identified at risk of flooding from rivers and the sea (Flood Zone)	No
		Critical Drainage Area (identified in the Surface Water Management Plan for Hillingdon)	No
History of flooding		Residents has advised of previous flooding but not provided details

Summary		A short intense rain event caused surface water to flow from areas behind these properties, tennis court and school field, into the gardens and two houses of these properties.	
London Borough of Hillingdon	Actions completed	The Council investigated and provided advice to residents, no new hard surfacing had been put in place. The tennis courts are porous and provide substantial more space for water to be absorbed than an otherwise urban environment, however most green space was saturated.	
Residents	Actions completed	None known

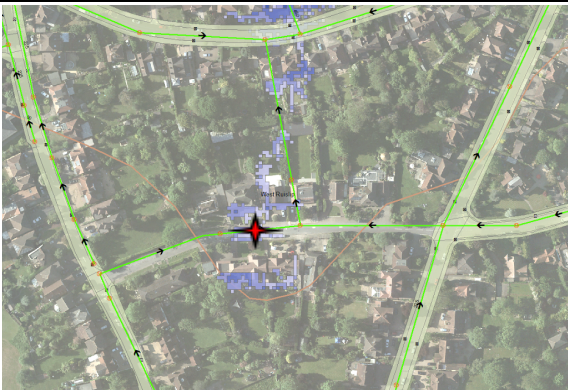
Area affected		14) King Edward's Road, Ruislip HA4 7A	
Date of flooding		23/06/2016	
Grid Reference		X 508836 Y 187359	
Land ownership		None	
Map of Area		Photo	
Location of flooding marked as a red star		None

Flooding duration		Approximately 1 hour	
Source of flooding		Surface water	
Cause/ Pathway		Water flowed down the King Edwards Road from both ends Sharps Lane to the west and Church Road to the east to the lowest point of the road and built up spilling over to front gardens.	
Impact of flooding	Flooded internally		2
	Flooded under floorboards		0
	Affected (ie gardens and front drive/garages)		1
Evidence	Reports from residents		Yes
	Identified on the flood map for surface water		Yes
	Identified at risk of flooding from rivers and the sea (Flood Zone)		No
	Critical Drainage Area (identified in the Surface Water Management Plan for Hillingdon)		No
History of flooding		None recorded	
Summary		The centre of King Edwards Road is low lying area susceptible to buildup of water.

London Borough of Hillingdon	Actions completed	The Council have investigated the flooding and this is a non adopted road, and have advised residents that it is the residents responsibility to maintain. It has also been identified that these drains flow into a Thames Water sewer which runs along the road and then north.	
Residents	Actions completed	The drains are cleared by a private company once every year.	
	To be completed	It is recommended that residents also report the issues to Thames Water so that is on their register. Residents should consider flood protection products to prevent water ingress.	
Thames Water		Not aware of any reports of flooding.

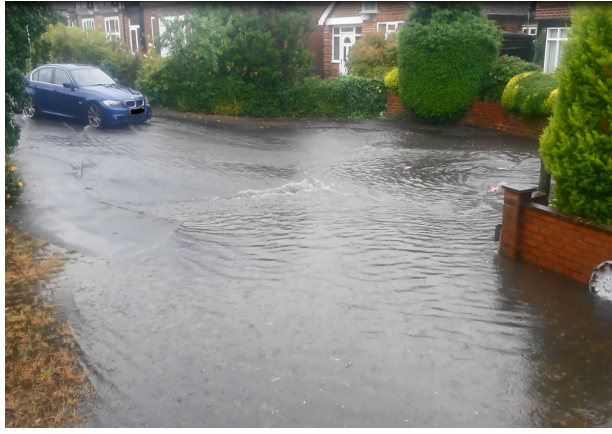
Area affected		15) Briarwood Drive, Northwood HA6 1P	
Date of flooding		23/06/2016	
Grid Reference		X 510493 Y 190293	
Land ownership		LBH adopted highway	
Map of Area		Photo	
Location of flooding marked as a red star		Snapshot of video provided by resident

Flooding duration		Evening approximately 1 hour	
Source of flooding		Foul sewer	
Cause/ Pathway		Inundation of foul water sewer by extreme amount of heavy rain.	
Impact of flooding		Flooded internally	1
		Flooded under floorboards	0
		Affected (ie gardens and front drive/garages)	2
Evidence		Reports from residents	Yes
		Identified on the flood map for surface water	Yes
		Identified at risk of flooding from rivers and the sea (Flood Zone)	No
		Critical Drainage Area (identified in the Surface Water Management Plan for Hillingdon)	No
History of flooding		Flooded previously in 2014, and four times this year (2016).	
Summary		A severe amount of heavy rain fell in a short period of time, overwhelming the surface water and foul water sewers in the area, flooding some people's back gardens.

London Borough of Hillingdon	Actions completed	The Council recommend residents draw up a Flood Plan. Further information can be found on the Hillingdon website. Also on products that can be purchased to protect homes from flooding through airbricks.	
Residents	To be completed	It is recommended that residents report the issue to Thames Water and fill in the sewer flooding questionnaire.	
Action by Thames Water		A property reported a bad smell two days after this event and this was due to concrete in the foul sewer line, which was cleared out. Sewer flooding is not on the Thames Water register at this location.

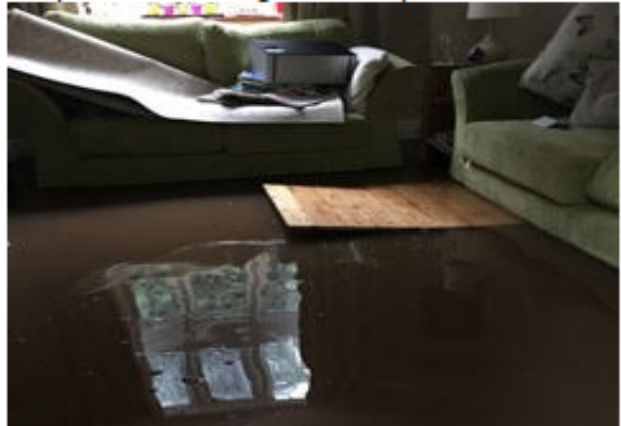
Area affected		16) Chestnut Avenue, Northwood, Hillingdon, HA6 1H	
Date of flooding		23/06/2016	
Grid Reference		X 509614 Y 190434	
Land ownership		Resident and LBH Parks & Open Spaces.	
Map of Area		Photo	
Location of flooding marked as a red star		Photo by resident of front lounge

Flooding duration		Unknown	
Source of flooding		Surface water	
Cause/ Pathway		The gullies on the road draining to the public surface water sewers were overwhelmed by the heavy rainfall.	
Impact of flooding		Flooded internally	1
		Flooded under floorboards	0
		Affected (ie gardens and front drive/garages)	1
Evidence		Reports from residents	Yes
		Identified on the flood map for surface water	Yes
		Identified at risk of flooding from rivers and the sea (Flood Zone)	No
		Critical Drainage Area (identified in the Surface Water Management Plan for Hillingdon)	No
History of flooding		On 15th September 2016 sandbags were needed to prevent a property from being flooded.

Summary		Surface water ran down Chestnut Avenue overwhelming the drainage system.	
London Borough of Hillingdon	Actions completed	<p>Highways Service -Gullies on Chestnut Avenue are checked as part of the normal annual maintenance and also cleared on 29/06/2016 following reports. Gullies will be maintained more frequently as an area of higher priority.</p> <p>Green Spaces Services manage the Cemetery. The drains in the cemetery were also checked by the Green Spaces Service, and were clear.</p> <p>Residents were provided with advice to also report the issue to Thames Water to ensure they checked their part of the drainage system for blockages.</p> <p>In addition the ditch that the sewers flow into has been checked and is clear.</p>	
Residents	To be completed	It is recommended that residents report the issue to Thames Water and fill in the sewer flooding questionnaire.	
Action by Thames Water		The site is not on the Thames Water Sewer Flooding Database. The site was visited on 29 June and the surface water sewers checked. They were all free flowing. The site was visited again on 11 October 2016 and the surface water sewers checked. They were all free flowing. Silted gullies were identified again as well as some of the private catch pits that needed clearing.

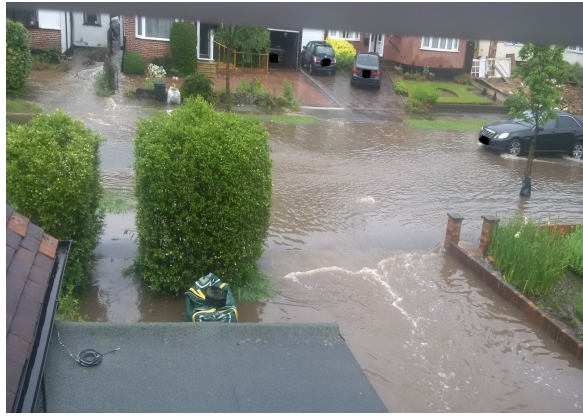
Area affected		17) Hillside Road, Northwood HA6 1P	
Date of flooding		23/06/2016	
Grid Reference		X 510617 Y 191043	
Land ownership		School and resident and LBH adopted Highway	
Map of Area		Photo	
Location of flooding marked as a red star		Photo provided by resident

Flooding duration		Unknown	
Source of flooding		Ordinary watercourse and surface water	
Cause/ Pathway		Water from a spring above Potter Street Hill and heavy rainfall spills from ordinary watercourse, across school ground towards the rear of properties along Hillside Road. There is a raised embankment here where water builds up until it flows over to properties at a lower level. It then flows on to Hillside road and over to the south side of the road where properties are lower again.	
Impact of flooding		Flooded internally	1
		Flooded under floorboards	0
		Affected (ie gardens and front drive/garages)	5
Evidence		Reports from residents	Yes

Identified on the flood map for surface water	Yes
		Identified at risk of flooding from rivers and the sea (Flood Zone)	No
		Critical Drainage Area (identified in the Surface Water Management Plan)	No
History of flooding		Exact date unknown	
Summary		Surface water also washed gravel from a driveway into a gully causing it to become blocked. Water built up on the road. Water then went under one of the houses and into a garden of another.	
London Borough of Hillingdon	Actions completed	Highways Service - has cleared gravel from the gullies on Hillside Road. The Council has also heard the petition from residents on the flooding and the proposed highway street calming in June, and amended proposals.	
Residents	Actions completed	The residents have petitioned the Council to install chicanes rather than speed tables as part of the proposed traffic calming measures. As an ordinary watercourse and not defined as a sewer the residents under which the culvert lies, may then be responsible as a riparian owner for the culvert in their private land.

Action by St John's School		The school manage the debris screen at the entrance to the culvert going underneath residential properties.

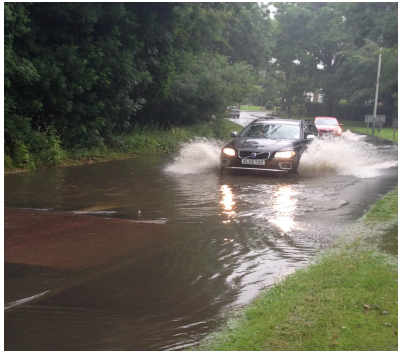
Area affected		18) Cuckoo Hill and Raisins Hill, Pinner HA5 2	
Date of flooding		23/06/2016	
Grid Reference		X 511106 Y 189657	
Land ownership		LBH and Resident	
Map of Area		Photo	
Location of flooding marked as a red star		Photo provided by resident

Flooding duration		18:00 - 00:00 midnight approximately	
Source of flooding		Surface water sewer	
Cause/ Pathway		Water built up on the road as a result of heavy rain, cars passing down the road, water splashed over the kerb causing water to flow across Cuckoo Hill open space and then on to the Raisins Hill Road, and into property	
Impact of flooding		Flooded internally	1
		Flooded under floorboards	0
		Affected (ie gardens and front drive/garages)	0
Evidence		Reports from residents	Yes
		Identified on the flood map for surface water	Yes
		Identified at risk of flooding from rivers and the sea (Flood Zone)	No
		Critical Drainage Area (identified in the Surface Water Management Plan)	No

History of flooding		None	
Summary		After a short intense period of rainfall, water overwhelmed the drainage system	
London Borough of Hillingdon Actions completed		<p>Highways Services - In addition to the normal maintenance the Council checked and cleared the 22 gullies along Cuckoo Hill on the 28th July 2016.</p> <p>Green Spaces Service have looked at options that water may be held back within the open space, and have created a small bund to hold some water back in the park.</p> <p>Flood and Water Management Officer has also met with and advised residents on action that they can take, such as getting flood proof doors.</p> <p>Thames Water sewers information obtained from Thames Water in 2017 are shown on the map above. They have now provided feedback to this report which state they believe there are no sewers. The Flood and Water management officer is raising this with Thames Water.</p>

Residents	To be completed	The Council advised residents on the products that can be purchased to protect homes from flooding such as flood proof doors.	
Action by Thames Water		Thames Water are now stating that their public sewer records do not show any sewers in Cuckoo Hill Road or Raisins Hill.

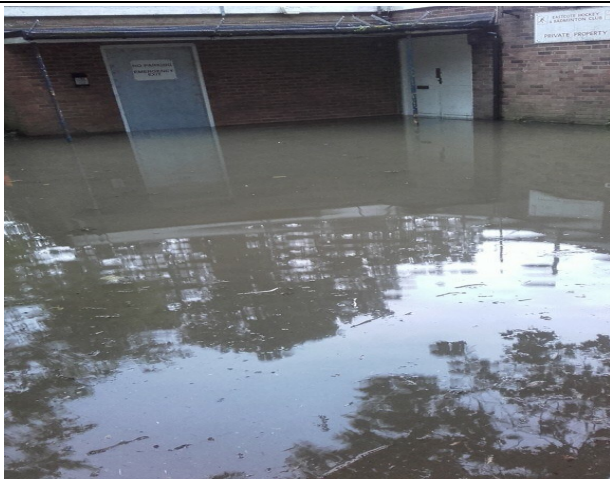
Area affected		19) Kings College Road, Ruislip HA4 7J	
Date of flooding		23/06/2016	
Grid Reference		X 509610 Y 188261	
Land ownership		LBH and Resident	
Map of Area		Photo	
Location of flooding marked as a red star		Photo taken from social media @eastcotehc https://twitter.com/eastcotehc/status/746094512477474816

Flooding duration		Unknown	
Source of flooding		Main river	
Cause/ Pathway		Flooding from the River Pinn in response to heavy rain	
Impact of flooding		Flooded internally	1
		Flooded under floorboards	0
		Affected (ie gardens and front drive/garages)	0
Evidence		Reports from residents	No
		Identified on the flood map for surface water	No
		Identified at risk of flooding from rivers and the sea (Flood Zone)	3b
		Critical Drainage Area (identified in the Surface Water Management Plan for Hillingdon)	No
History of flooding		None reported specifically but shown to be within the 1977 flood extent recorded by the Environment Agency.

Summary		Heavy rain caused the river to rise and spill over into the floodplain affecting the site.	
London Borough of Hillingdon	Actions completed	No report from the club	
Action by Hockey Club	Actions completed	Replaced flooring

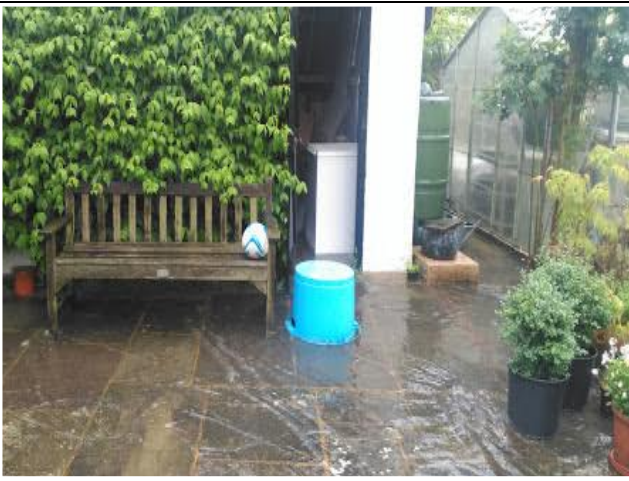
Area affected		20) Meadow Close, Ruislip HA4 8A	
Date of flooding		23/06/2016	
Grid Reference		X 509892 Y 188186	
Land ownership		LBH Green Space, private resident and LBH adopted highway	
Map of Area		Photo	
Location of flooding marked as a red star		Provided by resident

Flooding duration		17:00 - 01:00 approximately	
Source of flooding		River Pinn and Sewers	
Cause/ Pathway		Overtopping of the river restricting the ability of the surface water sewers to discharge.	
Impact of flooding		Flooded internally	1
		Flooded under floorboards	0
		Affected (ie gardens and front drive/garages)	1
Evidence		Reports from residents	Yes
		Identified on the flood map for surface water	Yes
		Identified at risk of flooding from rivers and the sea (Flood Zone)	3
		Critical Drainage Area (identified in the Surface Water Management Plan for Hillingdon)	No
History of flooding		None reported.	
Summary		After a short intense period of rainfall, the river levels had risen and caused flooding to the property internally.

London Borough of Hillingdon	Actions completed	The gully's on the road are maintained annually to clear them of debris	
Residents	Actions completed	Residents have got air bricks which automatically close.

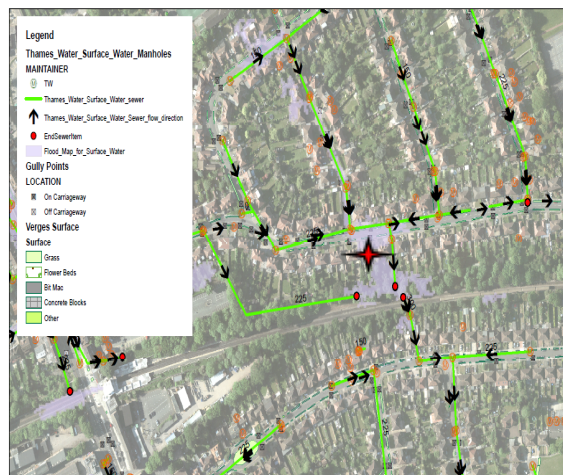
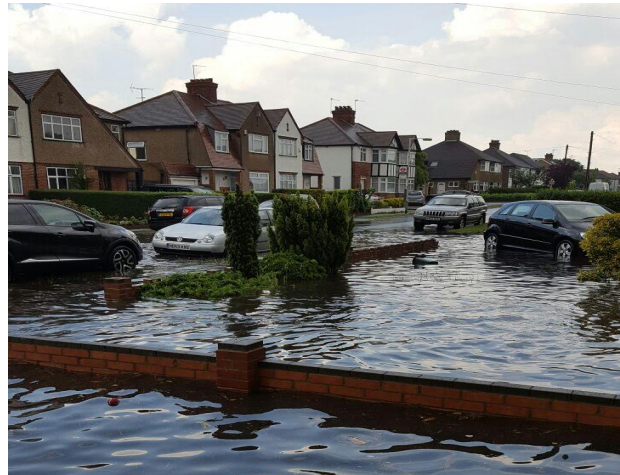
Flooding duration	17:30 - 18:30		
Source of flooding	Heavy rain overwhelming the drainage network, gullies, sewer and ordinary watercourse		
Cause/ Pathway	Water built up on the roads, spilling over to front gardens and garages		
Impact of flooding	Flooded internally		1
	Flooded under floorboards		1
	Affected (ie gardens and front drive/garages)		1
Evidence	Reports from residents		Yes
	Identified on the flood map for surface water		Yes
	Identified at risk of flooding from rivers and the sea (Flood Zone)		No
	Critical Drainage Area (identified in the Surface Water Management Plan for Hillingdon)		No
History of flooding	According to residents flooded in 2014 and 2015, and 8th Feb 2016, 8th June 2016 as well as subsequently on Sept 15th 2016

Summary	Regular flooding in heavy rain.		
London Borough of Hillingdon	Actions completed	Flood and Water Management Officer - The Council had investigated following reports of flooding in 2015 by the residents. It was noted that the sewers flow into the London Underground drainage network before flowing back into Thames Water sewers. A request was made to LU in 2015 to get the drainage system checked. The Council also again requested action from Thames Water and LU. Sewer performance issues were identified and corrected by London Underground. Residents were also advised to contact Thames Water to report the flooding. Highways Service - The Council in addition to their annual maintenance checked the gullies again after the event. Gullies will be maintained more frequently as an area of higher priority.

Residents concerned that the road camber slopes towards the properties and across the dropped kerb into driveways, and requesting additional gullies have been passed to the Highways Service to investigate and programme in any works considered appropriate.
	To be completed	The Highways Service are relaying the footpath to create a water check to ensure water is guided to the gully.
Residents	To be completed	The Council recommend residents draw up a Flood Plan. Further information can be found on the Hillingdon website, on products that can be purchased to protect homes from flooding through using airbricks. Anything of value should be stored above the ground in garages.
Action by Thames Water		Residents have reported flooding to Thames Water on previous occasions in February 2016. Thames Water identified debris in the sewer, which would need a sewer repair that would take in excess of 3 months due to permitting restrictions on non-emergency work. Resident in June advised that Thames Water had said they would be undertaking works in 6 weeks. Thames Water attended site in August, and replaced a section of pipe outside no 74.

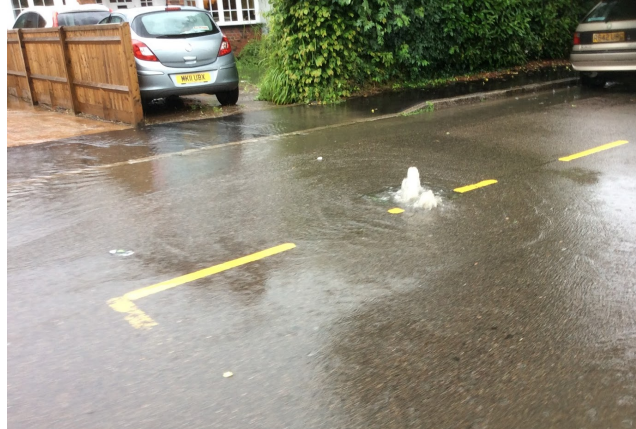
Area affected	24) Sharps Lane, Ruislip HA4 7J		
Date of flooding	23/06/2016		
Grid Reference	X 508841 Y 187568		
Land ownership	Resident and LBH adopted highway		
Map of Area		Photo	
Location of flooding marked as a red star		Photo provided by resident

Flooding duration	Four hours		
Source of flooding	Rainfall entering the foul sewer		
Cause/ Pathway	Overwhelming of foul water sewer by extreme amount of heavy rain		
Impact of flooding	Flooded internally		1
	Flooded under floorboards		0
	Affected (ie gardens and front drive/garages)		1
Evidence	Reports from residents		Yes
	Identified on the flood map for surface water		Yes
	Identified at risk of flooding from rivers and the sea (Flood Zone)		No
	Critical Drainage Area (identified in the Surface Water Management Plan for Hillingdon)		No
History of flooding	2014 and 2015		
Summary	Heavy rainfall caused the surface water and foul sewers in the road to become overwhelmed causing the properties to become flooded. Water entered one of the properties while others had their front drives and foundations affected

London Borough of Hillingdon	Actions completed	The Council recommended residents take action to protect their home by using products such as air brick covers	
Residents	Actions completed	The flooding has been reported to Thames Water by the residents. The flooding of 2015 was also reported to and investigated by Thames Water	
Action by Thames Water	Residents have said they have reported the issues to Thames Water but a Sewer Flooding Questionnaire has not been filled in
