FLOOD INVESTIGATION REPORT

23 June 2016

HILLINGDON
LONDON

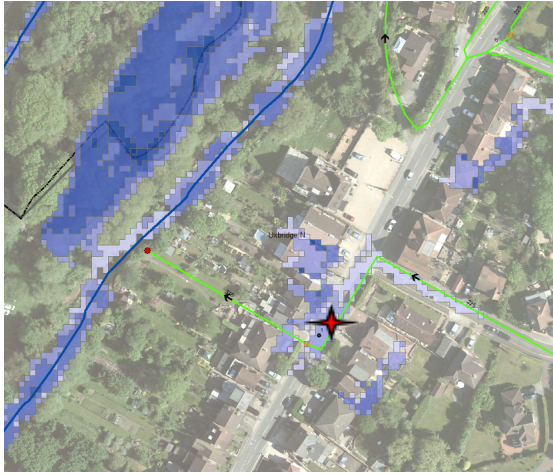
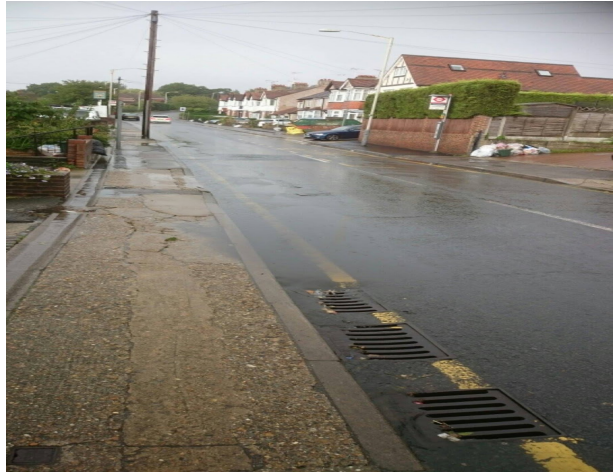
Area affected		27) Harefield Road, Uxbridge UB8 1P	
Date of flooding		23/06/2016	
Grid Reference		X 505690 Y 185033	
Land ownership		LBH Adopted Highway and private resident	
Map of Area		Photo	
Location of flooding marked as a red star		Photo provided by resident

Flooding duration		Evening	
Source of flooding		Surface water	
Cause/ Pathway		There was a short intense period of rainfall. The surface water built up on the road spilling over into the adjacent front garden.	
Impact of flooding		Flooded internally	1
		Flooded under floorboards	0
		Affected (ie gardens and front drive/garages)	0
Evidence		Reports from residents	Yes
		Identified on the flood map for surface water	Yes
		Identified at risk of flooding from rivers and the sea (Flood Zone)	No
		Critical Drainage Area (identified in the Surface Water Management Plan for Hillingdon)	No
History of flooding		September 2015. Surface water pools in front of the property

Summary		The surface water built up on the road	
London Borough of Hillingdon	Actions completed	The gullies were checked and no defects were found. There are 3 gullies in a short stretch which can be seen in the photo in order to ensure water can enter the Thames Water sewer. Gullies will be maintained more frequently by the Council Highways Service as an area of higher priority	
Residents	Actions completed	The residents have raised their drive and made it permeable	
Action by Thames Water		This is recorded on the Thames Water Flooding database. On investigation a large blockage was found and cleared on 05/09/2016. The flooding can solely be attributed to the blockage. The location has previously benefitted from a Thames Water funded alleviation scheme. The scheme is a pumped return flood storage tank which has been found to be in working order

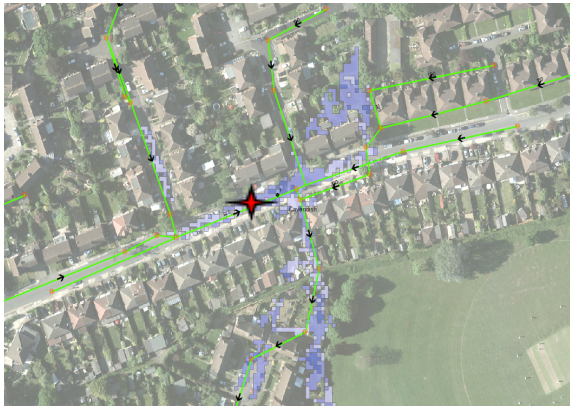
Area affected		28) Southbourne Gardens Ruislip HA4 9T	
Date of flooding		23/06/2016	
Grid Reference		X 511053 Y 187294	
Land ownership		Resident	
Map of Area		Photo	
Location of flooding marked as a red star		None

Flooding duration		Unknown	
Source of flooding		Surface water	
Cause/ Pathway		A short intense period of rain caused the surface water sewers to become overwhelmed. Water came down the driveway towards the the property. Water was coming up from underneath the floor	
Impact of flooding		Flooded internally	1
		Flooded under floorboards	0
		Affected (ie gardens and front drive/garages)	9
Evidence		Reports from residents	Yes
		Identified on the flood map for surface water	Yes
		Identified at risk of flooding from rivers and the sea (Flood Zone)	No
		Critical Drainage Area (identified in the Surface Water Management Plan for Hillingdon)	No
History of flooding		None reported	
Summary		Surface water couldn't drain from the road into the sewers causing the road and then the property to become flooded

London Borough of Hillingdon	Actions completed	The gulleys on the road are maintained by the Council annually. Gullies will be maintained more frequently as an area of higher priority	
Residents	Actions completed	Residents closed the road for 2 hours. The report of flooding has been made to Thames Water	
Action by Thames Water		Following on from the reported flooding it was identified that a private sewer was silted up, most likely from the recent flooding. This was cleared

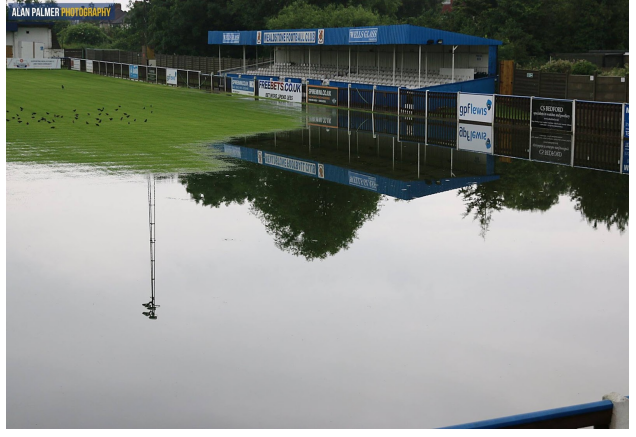
Area affected		30) Grosvenor Vale, Ruislip HA4 6J	
Date of flooding		23/06/2016	
Grid Reference		X 509709 Y 186782	
Land ownership		Private	
Map of Area		Photo	
Location of flooding marked as a red star		Photo taken from social media

Flooding duration		Unknown	
Source of flooding		Surface water	
Cause/ Pathway		A large amount of rain fell in a short period of time	
Impact of flooding		Flooded internally	1
		Flooded under floorboards	0
		Affected (ie gardens and front drive/garages)	0
Evidence		Reports from residents	No
		Identified on the flood map for surface water	Yes
		Identified at risk of flooding from rivers and the sea (Flood Zone)	No
		Critical Drainage Area (identified in the Surface Water Management Plan for Hillingdon)	Yes
History of flooding		None reported	
Summary		The football pitch was flooded after a large amount of rain fell.	
London Borough of Hillingdon	Actions completed	No direct reports to the Council. No specific work planned other than the normal maintenance to gullies in the area

Residents	Actions completed	None known

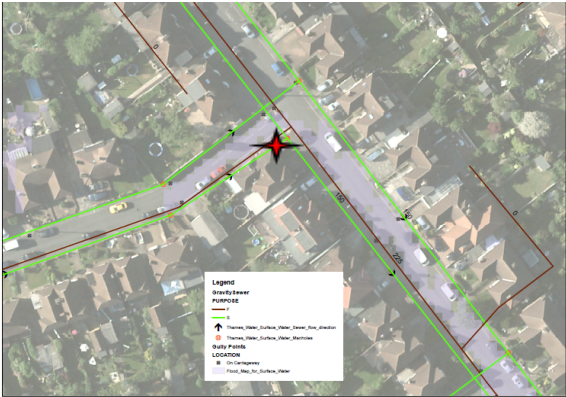
Area affected		31) Westfield Way at junction Beechwood Avenue, Ruislip, Hillingdon HA4 6H	
Date of flooding		23/06/2016	
Grid Reference		X 509629 Y 186482	
Land ownership		Resident and LBH adopted Highway	
Map of Area		Photo	
Location of flooding marked as a red star		None

Flooding duration		Unknown	
Source of flooding		Surface water	
Cause/ Pathway		Overwhelming of the surface water sewer	
Impact of flooding		Flooded internally	1
		Flooded under floorboards	0
		Affected (ie gardens and front drive/garages)	0
Evidence		Reports from residents	Yes
		Identified on the flood map for surface water	Yes
		Identified at risk of flooding from rivers and the sea (Flood Zone)	No
		Critical Drainage Area (identified in the Surface Water Management Plan for Hillingdon)	No
History of flooding		28th July 2014	
Summary		Heavy rain caused the sewers to become overwhelmed	
London Borough of Hillingdon	Actions completed	The Council have provided advice to the resident to incorporate flood protection measures. The Council has requested that Thames Water investigate the whole length of surface water sewer to the point of discharge into a river so that it can be confirmed that the system functions appropriately. They have stated that this is an excessive distance to request to be investigated with high expense and that sufficient investigation has been carried out through integrity investigations within the area and no further action is proposed.

Residents	Actions completed	None known	
Action by Thames Water		Sewer integrity was assessed for the properties that reported the flooding. No defects were found.

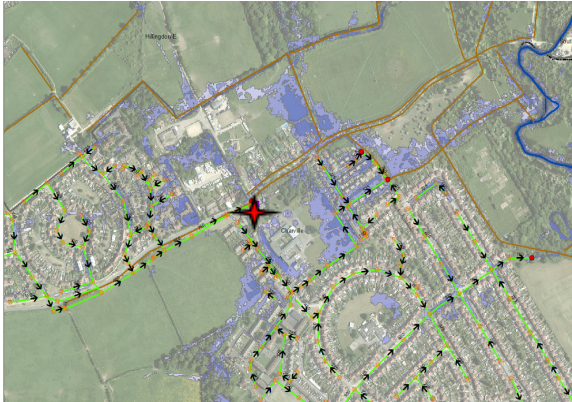
Area affected	32) Bury Avenue, Hayes UB4 8L		
Date of flooding	23/06/2016		
Grid Reference	X 509075 Y 183213		
Land ownership	London Borough of Hillingdon		
Map of Ar	Photo		
Location of flooding marked as a red star		None

Flooding duration	Unknown		
Source of flooding	Surface water		
Cause/ Pathway	A large amount of rain fell in a short period causing the sewers to become overwhelmed		
Impact of flooding	Flooded internally		1
	Flooded under floorboards		0
	Affected (ie gardens and front drive/garages)		0
Evidence	Reports from residents		Yes
	Identified on the flood map for surface water		Yes
	Identified at risk of flooding from rivers and the sea (Flood Zone)		No
	Critical Drainage Area (identified in the Surface Water Management Plan for Hillingdon)		No
History of flooding	None reported		
Summary	The sewers became overwhelmed causing the property to become flooded		
London Borough of Hillingdon	Actions completed	The gully's within the car park have been cleared by the Council Highways Service subsequent to the event. Gullies will be maintained more frequently as an area of higher priority

Residents	Actions completed	None known	
Action by Thames Water	This location was not reported to Thames Water and so no action has been taken

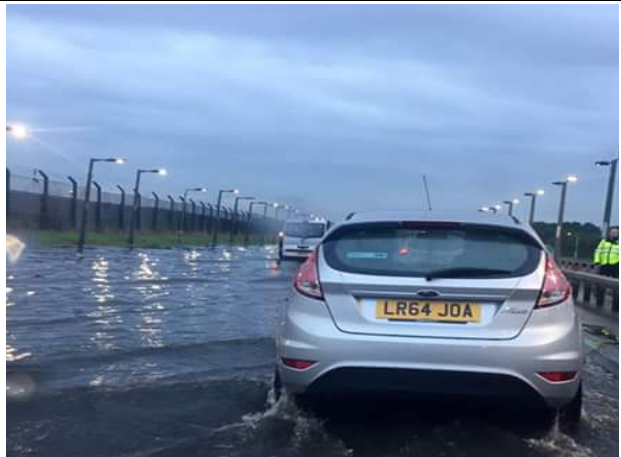
Area affected	b) A40 Northolt, Ruislip HA4	
Date of flooding	23/06/2016	
Grid Reference	X 509245 Y 184509	
Land ownership	TfL as Highway Authority	
Map of Area	Photo	
Location of flooding marked as a red star	Photograph taken from social media/resident

Flooding duration	From 18:00 pm until 02:30am 24th June	
Source of flooding	Surface water	
Cause/ Pathway	To be investigated further, initial findings appear that the gullies and then surface water sewer were overwhelmed by very heavy rain and not able to freely discharge as the Yeading Brook was at a high level	
Impact of flooding	Flooded internally	1
	Flooded under floorboards	0
	Affected (ie gardens and front drive/garages)	0
Evidence	Reports from residents	Yes
	Identified on the flood map for surface water	Yes
	Identified at risk of flooding from rivers and the sea (Flood Zone)	3b
	Critical Drainage Area (identified in the Surface Water Management Plan for Hillingdon)	Yes

History of flooding	A40 previously flooded in 2014 nearer to Hillingdon Underground Station. (16.6mm 8th June which affected other parts of Ruislip did not result in flooding here)	
Summary	<p>After a short and intense period of rainfall, the drainage on the A40, Thames Water surface water sewers and the Yeading Brook were overwhelmed causing flooding on the A40. Ownership of these pipes are under discussion with TfL as they are most likely highway drains and not surface water sewers.</p> <p>Flooding across the three lanes of the eastbound carriageway from the Hillingdon on slip A40, restricting access onto and past this area of the A40 causing traffic to build up.</p> <p>The Environment Agency issued a Flood Alert on the Yeading Brook on the 17th June which remained in place until the 23rd June. The nearest gauge was Northolt Gutteridge Wood, directly next to the location of flooding. The highest level was at 00:15 on the 24th which read 1.842 m</p>

(flooding is expected at 1.58m). Heavy rainfall of 11.8mm within an hour recorded at the RAF Northolt Gauge
London Borough of Hillingdon	To be completed	Investigate what action TfL and Thames Water and RAF Northolt are taking to alleviate flooding.
Transport for London	Actions completed	Following a request for information from the Council TfL have confirmed that contractors working on their behalf were there and required a number of tankers to take water away.
	To be completed	Investigate and determine appropriate actions and share discuss with the Council as the Lead local Flood Authority.
Environment Agency	To be completed	Review flood warning triggers and if Tfl are signed up to receive them in this area.

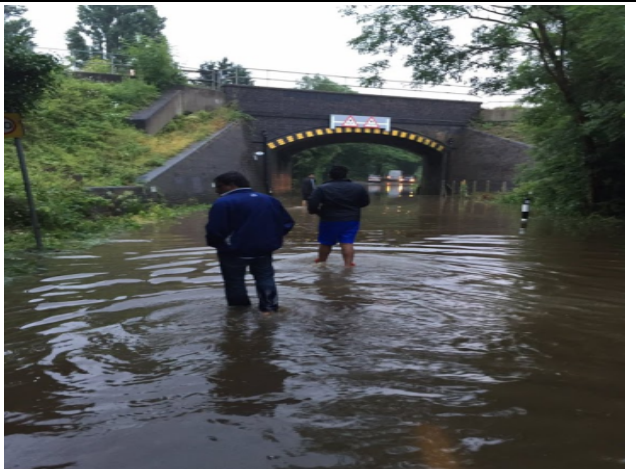
Area affected		c) Breakspear Road South, Ickenham UB10 8H	
Date of flooding		23/06/2016	
Grid Reference		X 507194 Y 187196	
Land ownership		Network Rail and LBH as adopted Highway	
Map of Area		Photo	
Location of flooding marked as a red star		Photographs taken by resident. Breakspear Road South

Flooding duration		17:30 -19:30	
Source of flooding		Ordinary watercourses	
Cause/ Pathway		Overwhelming of ordinary watercourse and culverts under the road by extreme amount of heavy rain which flow into the River Pinn.	
Impact of flooding		Flooded internally	1
		Flooded under floorboards	0
		Affected (ie gardens and front drive/garages)	0
Evidence		Reports from residents	Yes
		Identified on the flood map for surface water	Yes
		Identified at risk of flooding from rivers and the sea (Flood Zone)	No
		Critical Drainage Area (identified in the Surface Water Management Plan for Hillingdon)	No
History of flooding		Breakspear Road South has flooded many times in December 2012, 2013, 2014 and 2015, 11th January 2016. See previous Flood Investigation Dec 2013- June 2014

Summary		A severe amount of heavy rain fell in a short period of time, overwhelming the ordinary watercourses and restricting access. Flood water flowed down roads, pooling at low points, underneath the railway bridge down Breakspear Road South. The water was up to the top of car wheels in some places	
London Borough of Hillingdon	Actions completed	Flood and Water Management Officer has had ongoing discussions and met with with Network Rail following previous flooding in 2013/2014. The Council continues to work with Network Rail to identify measures. The flood risk issues in this area have also been raised by the Council to Hs2, which will cross Breakspear Road South just to the north of this location.

The Council Highways Service is considering a number of options including maintaining the gullies more frequently as an area of higher priority, and also placing appropriate signage to make drivers aware of the risks of flooding.
Network Rail	To be completed	The ordinary watercourses causing the main issues lie on Network Rail land. They have taken some action since floods in 2013/2014 to reduce the risk following previous reports, including altering culvert alignment and rebuilding culvert entrance. However further work has been identified by the Council which was requested of Network Rail in 2016 including identifying condition of culvert along both sides of the road south of the embankment on Network Rail land, which is yet to be undertaken.

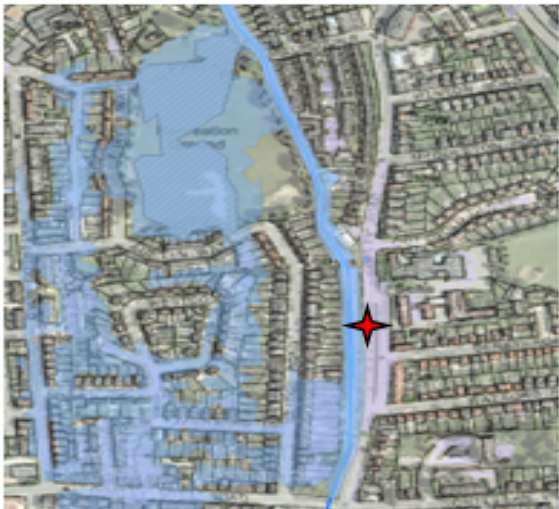
Area affected	d) Cowley Road, Uxbridge UB8 2	
Date of flooding	23/06/2016	
Grid Reference	X 505376 Y 183544	
Land ownership	Adopted Highway	
Map of Area	Photo	
Location of flooding marked as a red star	Photograph taken from Alan Hayes https://twitter.com/Uxbridge511 on social media

Flooding duration	Unknown approximately 1 hr 17:30 to 18:30	
Source of flooding	Surface water sewer	
Cause/ Pathway	Heavy rain, overwhelming the road gullies and surface water sewer	
Impact of flooding	Flooded internally	1
	Flooded under floorboards	0
	Affected (ie gardens and front drive/garages)	0
Evidence	Reports from residents	Yes
	Identified on the flood map for surface water	Yes
	Identified at risk of flooding from rivers and the sea (Flood Zone)	No
	Critical Drainage Area (identified in the Surface Water Management Plan for Hillingdon)	No
History of flooding	Cowley Road has previously flooded in 2012, 28th July 2014 and 26th August 2015. 23rd June, and subsequently to this event in 12th July and 15th September 2016.

Summary	<p>Very short intense rainfall when the river is higher than normal appear to overwhelm the drainage system. Water cannot discharge from the road into the river.</p> <p>A large amount of water was flowing down roads, unable to drain away. Roads still passable, however the nearby Polling station at Whitehall school tweeted for people to access it from an alternative entrance on Whitehall Road. @WestDraytonComC.</p> <p>A video posted by Get West London shows the same road being flooded on the 13th July http://www.getwestlondon.co.uk/news/west-london-news/watch-drivers-battle-through-flash-11609269 and 15th September http://www.getwestlondon.co.uk/news/west-london-news/flash-flooding-predictions-come-true-11892712 Stating it was the 3rd time this summer.</p>
