FLOOD INVESTIGATION REPORT December 2013 - June 2014

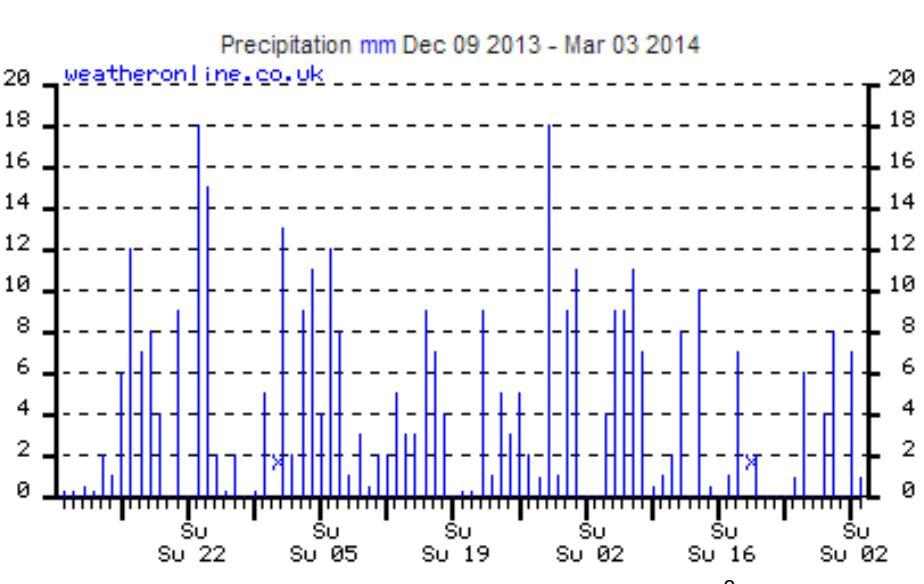
Table 1 Rainfall from Dec 09 to March 3rd from 'Weather Online'³

It is considered that there has been the highest rainfall on record over recent months across the country. From a rain gauge operated by the Council's Green Spaces team at Haste Hill Golf Club, Hillingdon received 157mm in January and 40mm between February 1st - 14th. This was consistent across the borough as can be seen from data obtained from a weather station at Heathrow where Table 1 shows data from December to February.
