Fire Risk Assessment

ADDRESS: 1-96 Melbourne House,
Yeading Lane,
Hayes,
Middlesex UB4 9LJ.

Fire Risk Assessment Report

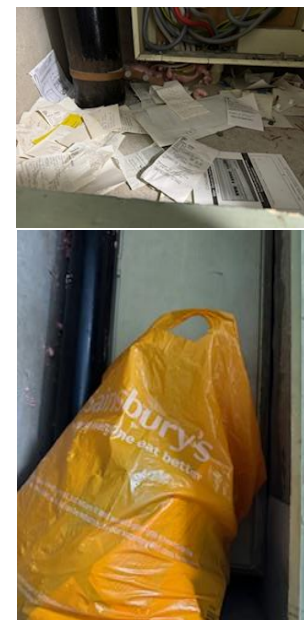
Sect Ref	Priority	Issue and recommendation	Issue Type	Issue Code	Photograph (If applicable)
5.2 Are records available to confirm that it is routinely checked?	Medium	The maintenance regime for the lightning protection is unknown. It should be ensured that there is an appropriate servicing and maintenance contract in place.	05-Electrical	07-Service	
8.2 Do combustible materials appear to be separated from ignition sources?	Medium	There was some combustible rubbish in the electrical meter/ riser cupboards near flats 6 and 18. All combustible materials should be removed from cupboards.	04-Combustible Items	16-General housekeeping

8.1	See 8.2						
8.2	There was some combustible rubbish in the electrical meter/ riser cupboards near flats 6 and 18. All combustible materials should be removed from cupboards.

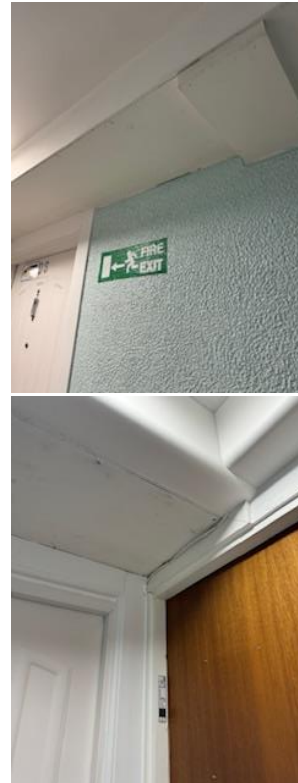
Sect Ref	Priority	Issue and recommendation	Issue Type	Issue Code	Photograph (If applicable)
14.1 Is compartmentation of a reasonable standard?	Low	The fire stopping within service shafts between flats and communal areas and above communal fire doors could not be confirmed. A compartmentation survey should be carried out to determine if the levels of fire stopping is adequate.	02-Compartmentation	01-Survey & Report

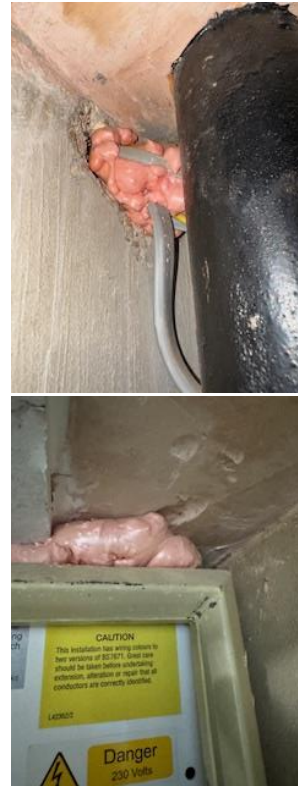
Sect Ref	Priority	Issue and recommendation	Issue Type	Issue Code	Photograph (If applicable)
14.1 Is compartmentation of a reasonable standard?	Medium	Expanding foam has been used to seals holes and gaps within meter/ riser cupboards. The fire stopping properties of this foam should be confirmed or foam removed and replaced with an accredited product.	02-Compartmentation	10-Provide certification

14.1	Expanding foam has been used to seals holes and gaps within meter/ riser cupboards. The fire stopping properties of this foam should be confirmed or foam removed and replaced with an accredited product.
